**STS-102 (BI106)
FLIGHT READINESS REVIEW**

February 27, 2001

Solid Rocket Booster

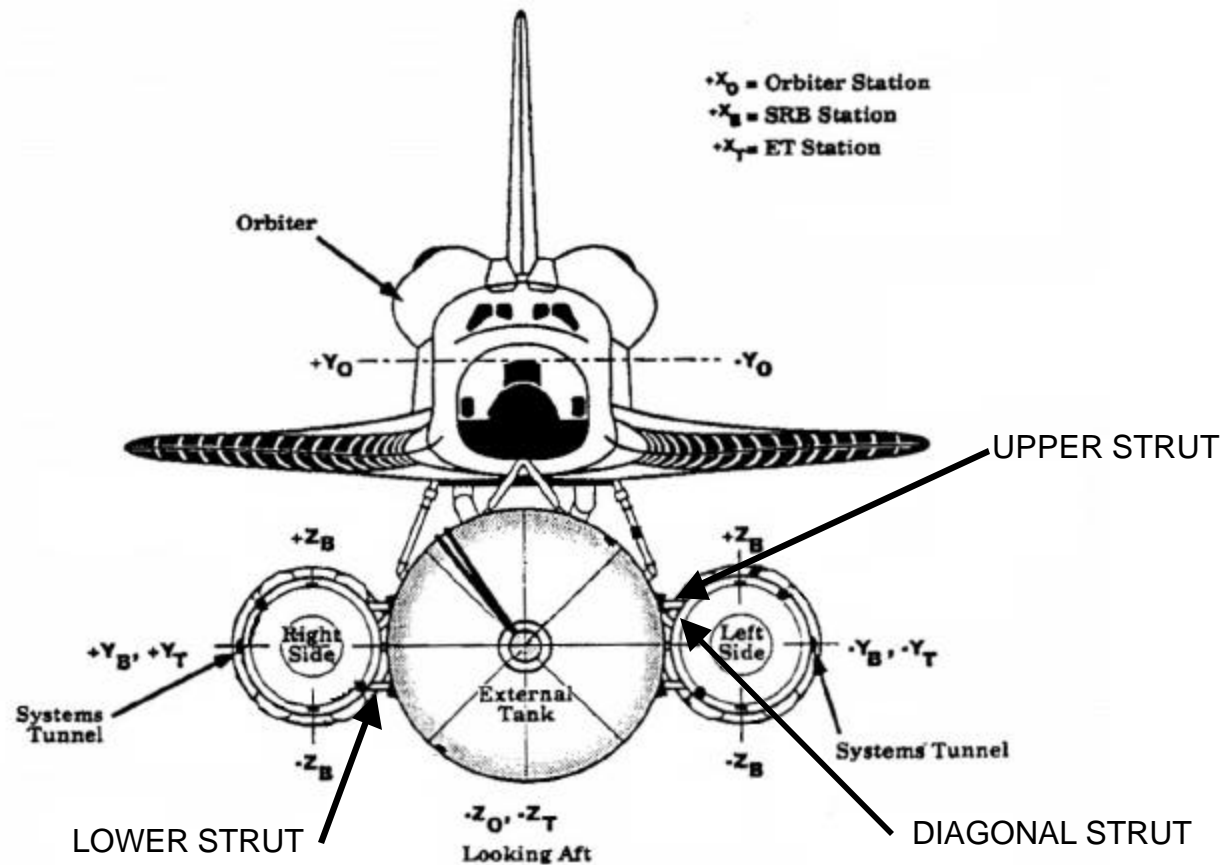
SRB-8

- Interface between connector insert and adapter moved during torquing of adapter jam nut
 - Pigtail connects ETAR cable to system “B” NSI, ET side
 - Broken torque stripe found between connector insert and adapter

STRUT LOCATIONS
